GLULAM BEAM REPAIR/REINFORCEMENT TINORA HIGH SCHOOL DEFIANCE, OHIO

By: Gary W. Gray, PE and Paul C. Gilham, PE

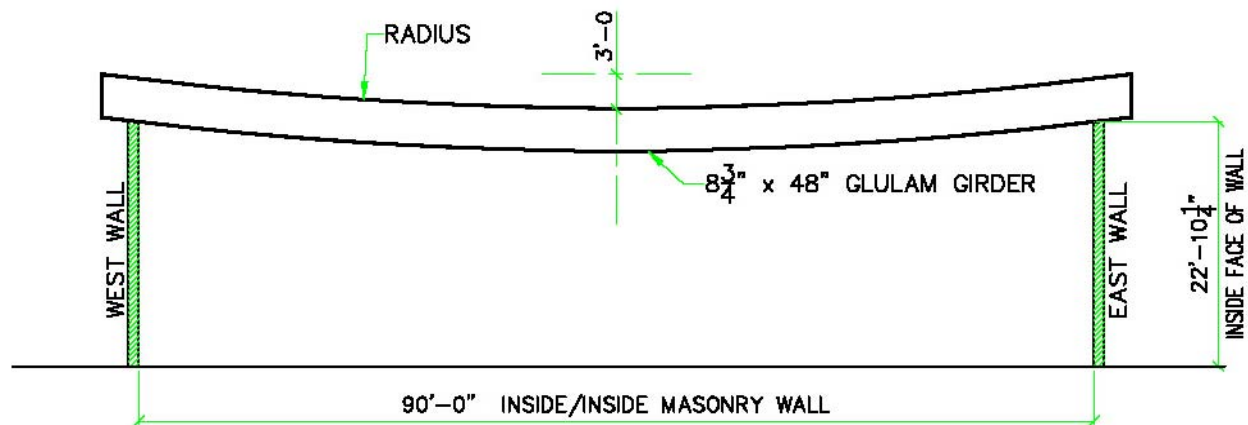
Figure 1. Profile of glulam beam girder. (Beam #5)

One of the beams located directly above the center court line (Beam #5 – see Figure 1) had been reported to have cracked near the mid-span. Upon investigation of this beam, it was determined that the glulam beam had undergone a structural “bending failure” and was no longer adequate to safely support the roof above. The failure had initiated at a knot near mid-span at the bottom lamination and the crack had propagated upward and outward in a flat “V” pattern which is a classic type bending failure in wood beams. The crack had propagated up from the bottom face of the beam approximately 12" at the time of the structural investigation.

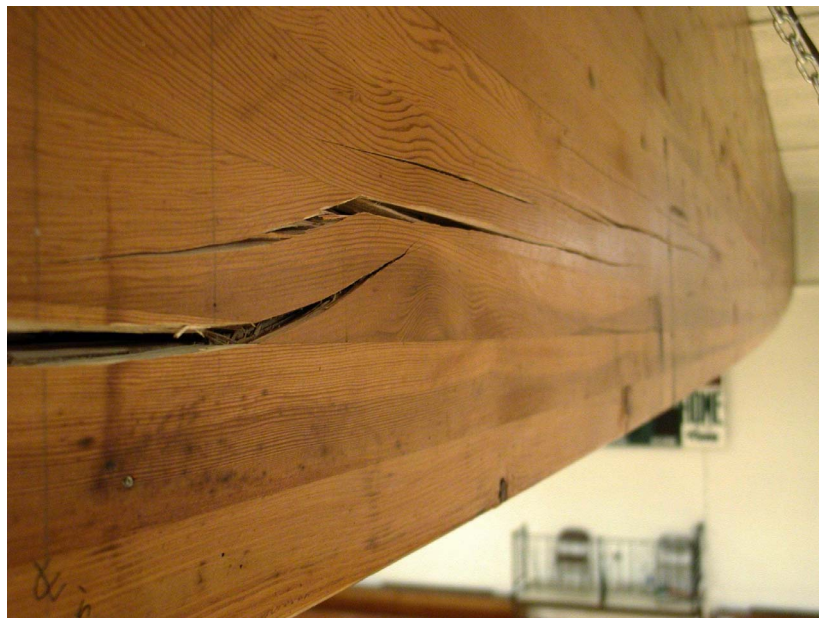
Figure 2. Failed beam due to overstress in bending.

Beam #5 had deflected approximately 3" lower than the adjacent beams and the open crack at the failure zone was approximately $\frac{3}{4}$ " wide and completely through the full width of the beam. The section of beam above the crack (although overstressed) maintained enough structural integrity for a period of time to prevent a catastrophic collapse of the beam. There were no visible signs of distress at the masonry walls supporting the beam ends due to horizontal displacements resulting from the beam failure.

The design analysis indicated that the addition of the ballast weight nearly 20 years earlier had resulted in an approximate 40% increase in dead load only bending stresses. In addition, glulam beams manufactured prior to 1970 did not utilize specific graded tension laminations, which are now required by current laminating standards. Various full-size glulam beam tests have been performed by the American Institute of Timber Construction and other agencies which have predicted an allowable stress reduction of approximately 25% for glulam beams manufactured without these specific graded tension laminations. This equates to the beams used in the Tinora High School gymnasium being overstressed approximately 24% under permanent dead loads and approximately 62% under full design load requirements (DL + SL). These beams were originally designed assuming an $F_b=2400$ psi (extreme fiber bending stress), however the allowable bending stress used in the investigation analysis included the recommended 25% reduction or $F_b=1800$ psi. Many experienced timber engineers use this approach when evaluating older glulam timber structures.

Prior to the structural investigation, the owner had placed a temporary column support at the center span of the beam, but it was determined that the support was not adequate to safely shore up the beam. It was further recommended that the beam be adequately shored up using two 6 x 6 x $\frac{1}{4}$ " HSS steel columns to prevent any further damage to the beam and to safe guard against a beam collapse. These two temporary supports were located symmetrically 9 feet from the center of the beam to allow for direct access to the bottom of the beam at the failure zone for possible repair applications.

Based on the extent of damage sustained by Beam # 5 and the calculated overstress condition of the other glulam beams, Gray Engineering and Design recommended a repair and reinforcement method which included shear dowel reinforcing and the addition of post-tensioning cables to be utilized for both the “failed” beam and the remaining beams. This method was selected for two main reasons, the first giving consideration for the basketball court clearance to the bottom of the beams. The existing clearance was only 20 ft. ± which was only marginal at best when considering a minimum recommended clearance of 25 ft. by today’s standards. Secondly, since Beam #5 was already in a “failed” state, a repair technique was needed which would restore the bending moment capacity of the beam to the confidence level needed. The post-tensioning technique provided a method with a proven track record (this system has been used effectively since the early 1980s) and the ability to apply a pre-calculated level of stress to the failed beam

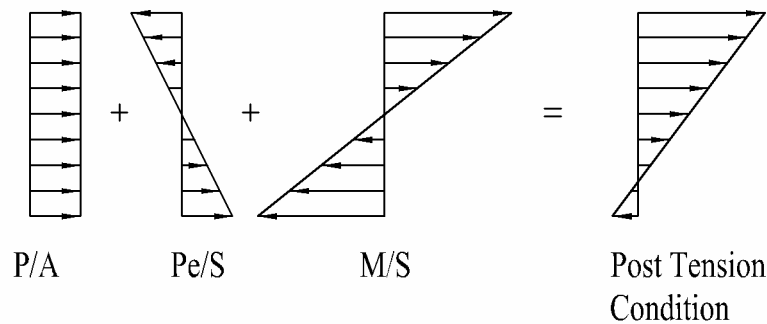
Figure 3. Combination of stress with post-tensioned system.

Using this system, post-tensioning cables were installed on the beam soffit. When post-tensioned, these cables applied a compressive force to the beam. This force was applied eccentrically to the beam's neutral axis and produced a bending moment to the member. Figure 3 shows the combination of the post tensioning stresses and the applied stresses. The P/A compressive stresses and P_e/S bending stresses are due to the cable tensioning. The M/S bending stress is in the opposite sense of the cable stresses and is due to the applied dead and live loads. The resulting tensile stress at the bottom of the beam in the post tension condition must be less than the allowable tensile stress of the member.

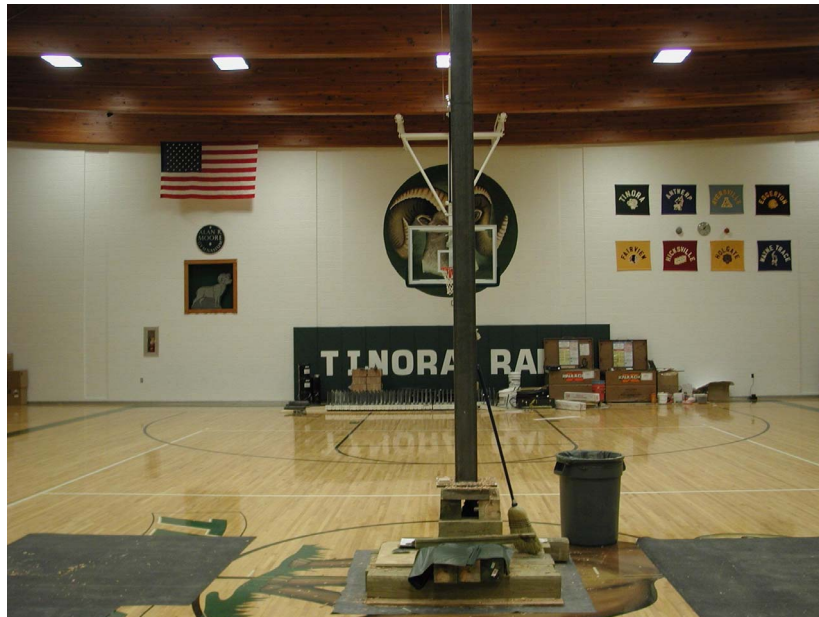
Figure 4. 6 x 6 HSS member used to jack beam to unloaded position during beam repair.

1. The beams were jacked up to approximately an unloaded position. A 6 x 6 x $\frac{1}{4}$ " HSS was installed on timber cribbing with a 20 ton bottle jack at the base. The jack was used to close the cracks as much as possible.

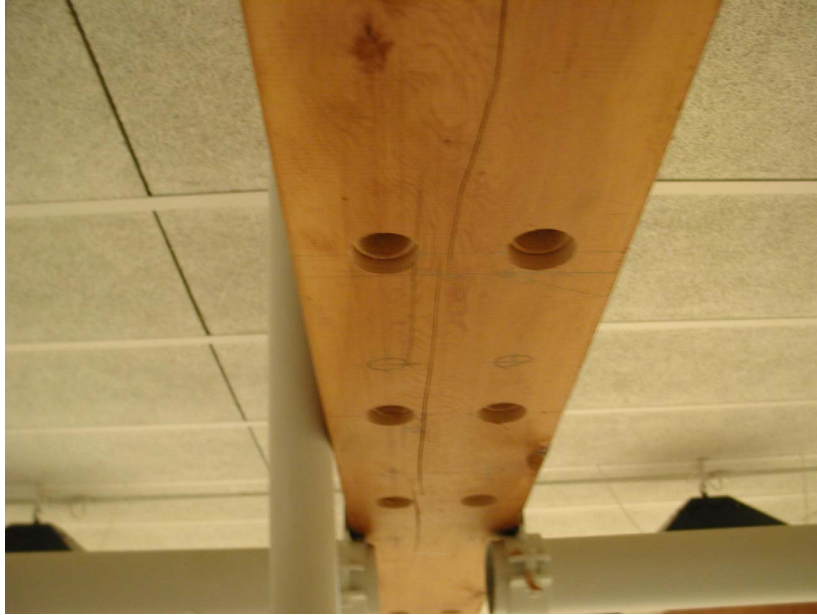
Figure 5. Holes drilled to receive Post-Tensioning Anchor Brackets.

2. 1 3/8" holes were drilled vertically in the beam from the soffit to a point 6" above the highest crack. Small port holes are drilled near the bottom of the beam and just below the top of the vertical hole.

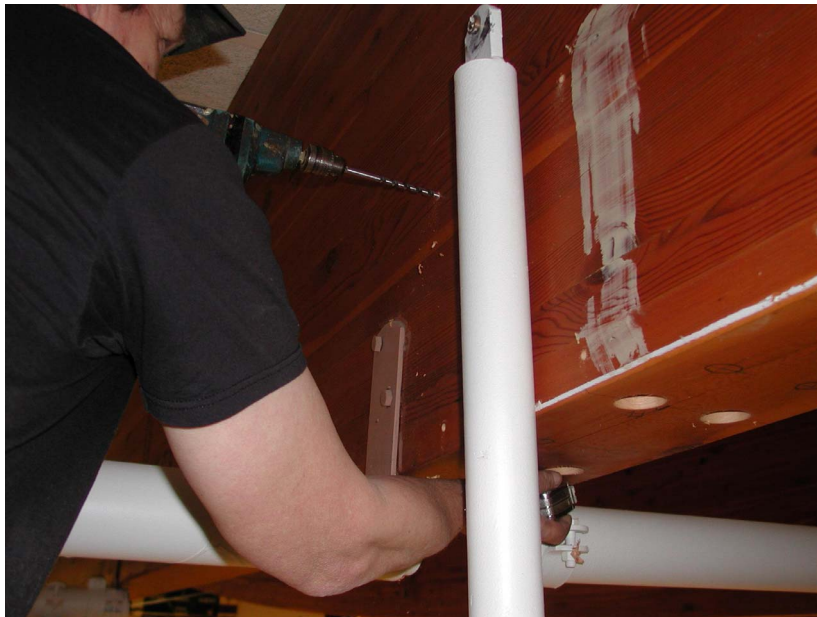
Figure 6. Drilling the injection and exhaust ports.

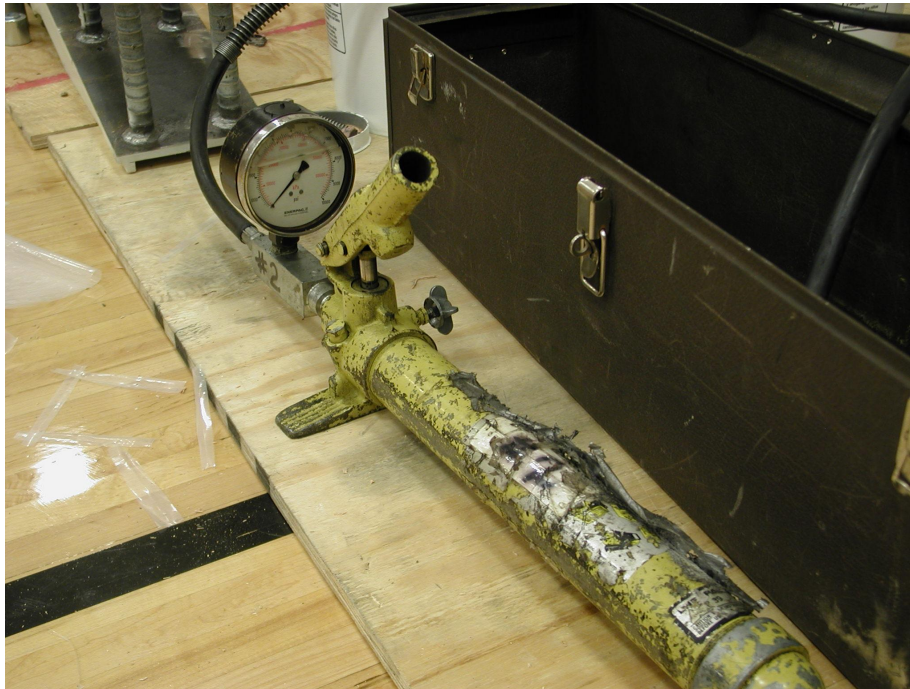
Figure 7. Calibrated Hydraulic jack.

6. The cables are installed into the jacking assemblies and tensioned. This process begins with the innermost cables and continues outward. Five pairs of cables are required to supply the required negative moment and compression. Calibrated hydraulic jacks are used to apply the tension to the cables.

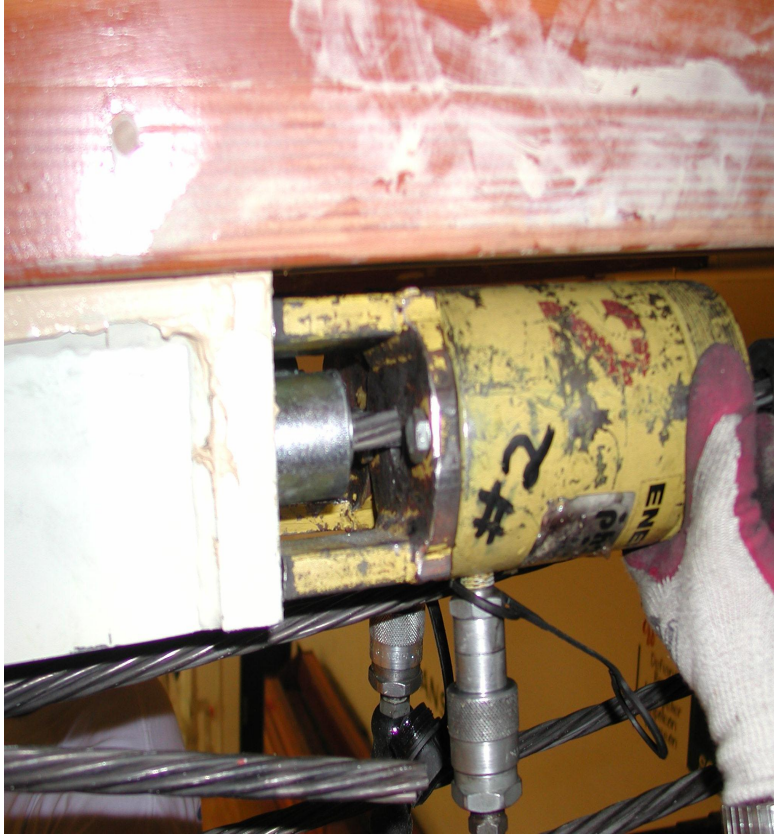
Figure 8. Head of hydraulic jack pulling on cable.

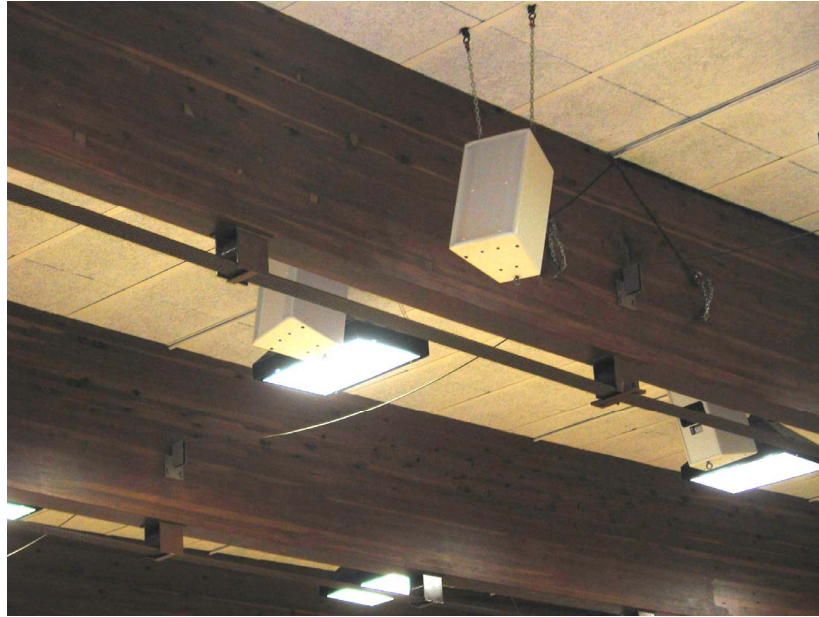
Figure 9. Completed repair/reinforcement of glulam girder beams.

One of the 90'-0" roof beams at Tinora High School in Defiance, Ohio failed due to a combination of cumulative effects of snow loads, inadequate roof drainage, and increased dead loads from the original design. The beam failed in bending near mid-span. The damage extended up 12" from the soffit. A review of the original beam lay-up and current dead and snow load requirements indicated that the beams were severely overstressed. A repair design was selected that included installation of epoxy and rebar dowels and post-tensioning using $\frac{1}{2}$ " ϕ high strength cables. The repairs were accomplished and the capacity of the beam was increased to meet current load requirements.
