WESTERN WOOD STRUCTURES, INC.

Structural Timber Repairs

REINFORCING FOR SHEAR FAILURES / REPAIR OF EXCESSIVE SPLITTING

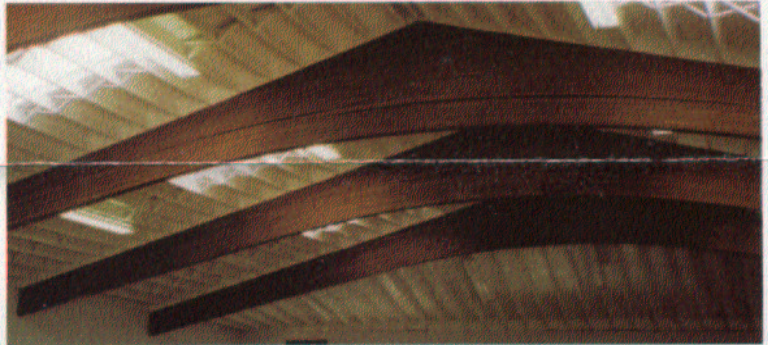
WWS installed steel dowels in epoxy filled holes to repair a radial tension failure that occurred to these peaked & cambered Glulams that carry the roof structure of a horse arena in Sherwood, Oregon.

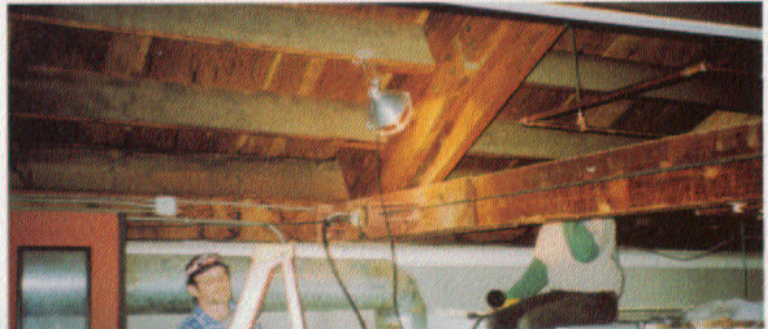
These bowstring trusses were post tensioned with high strength cable as a means of upgrading to meet current code requirements. The use of cable allows for greater flexibility in working with existing ceiling joists or other obstructions. Many building departments require existing beams & trusses be upgraded to meet current code in the event of a building remodel.

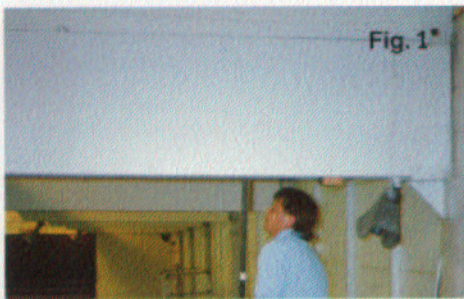
Fig. 1*

Fig. 1 - Holes are drilled for cable anchorage connectors.

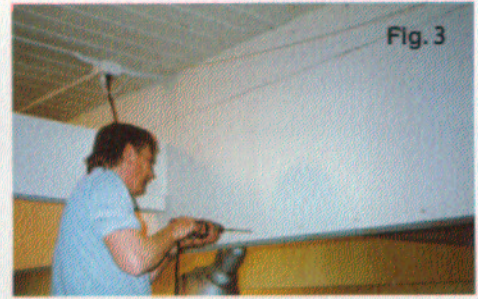
Fig. 3 - An injection port is drilled at the bottom of the cable anchorage connector hole.
